February 19, 2025

**SUBJECT: Pre-Renovation Asbestos Inspection Report**  
Fire System Upgrade Project  
Brick Breeden Fieldhouse  
Montana State University  
Bozeman, Montana  
Tetra Tech Project No. 117-001109-25003

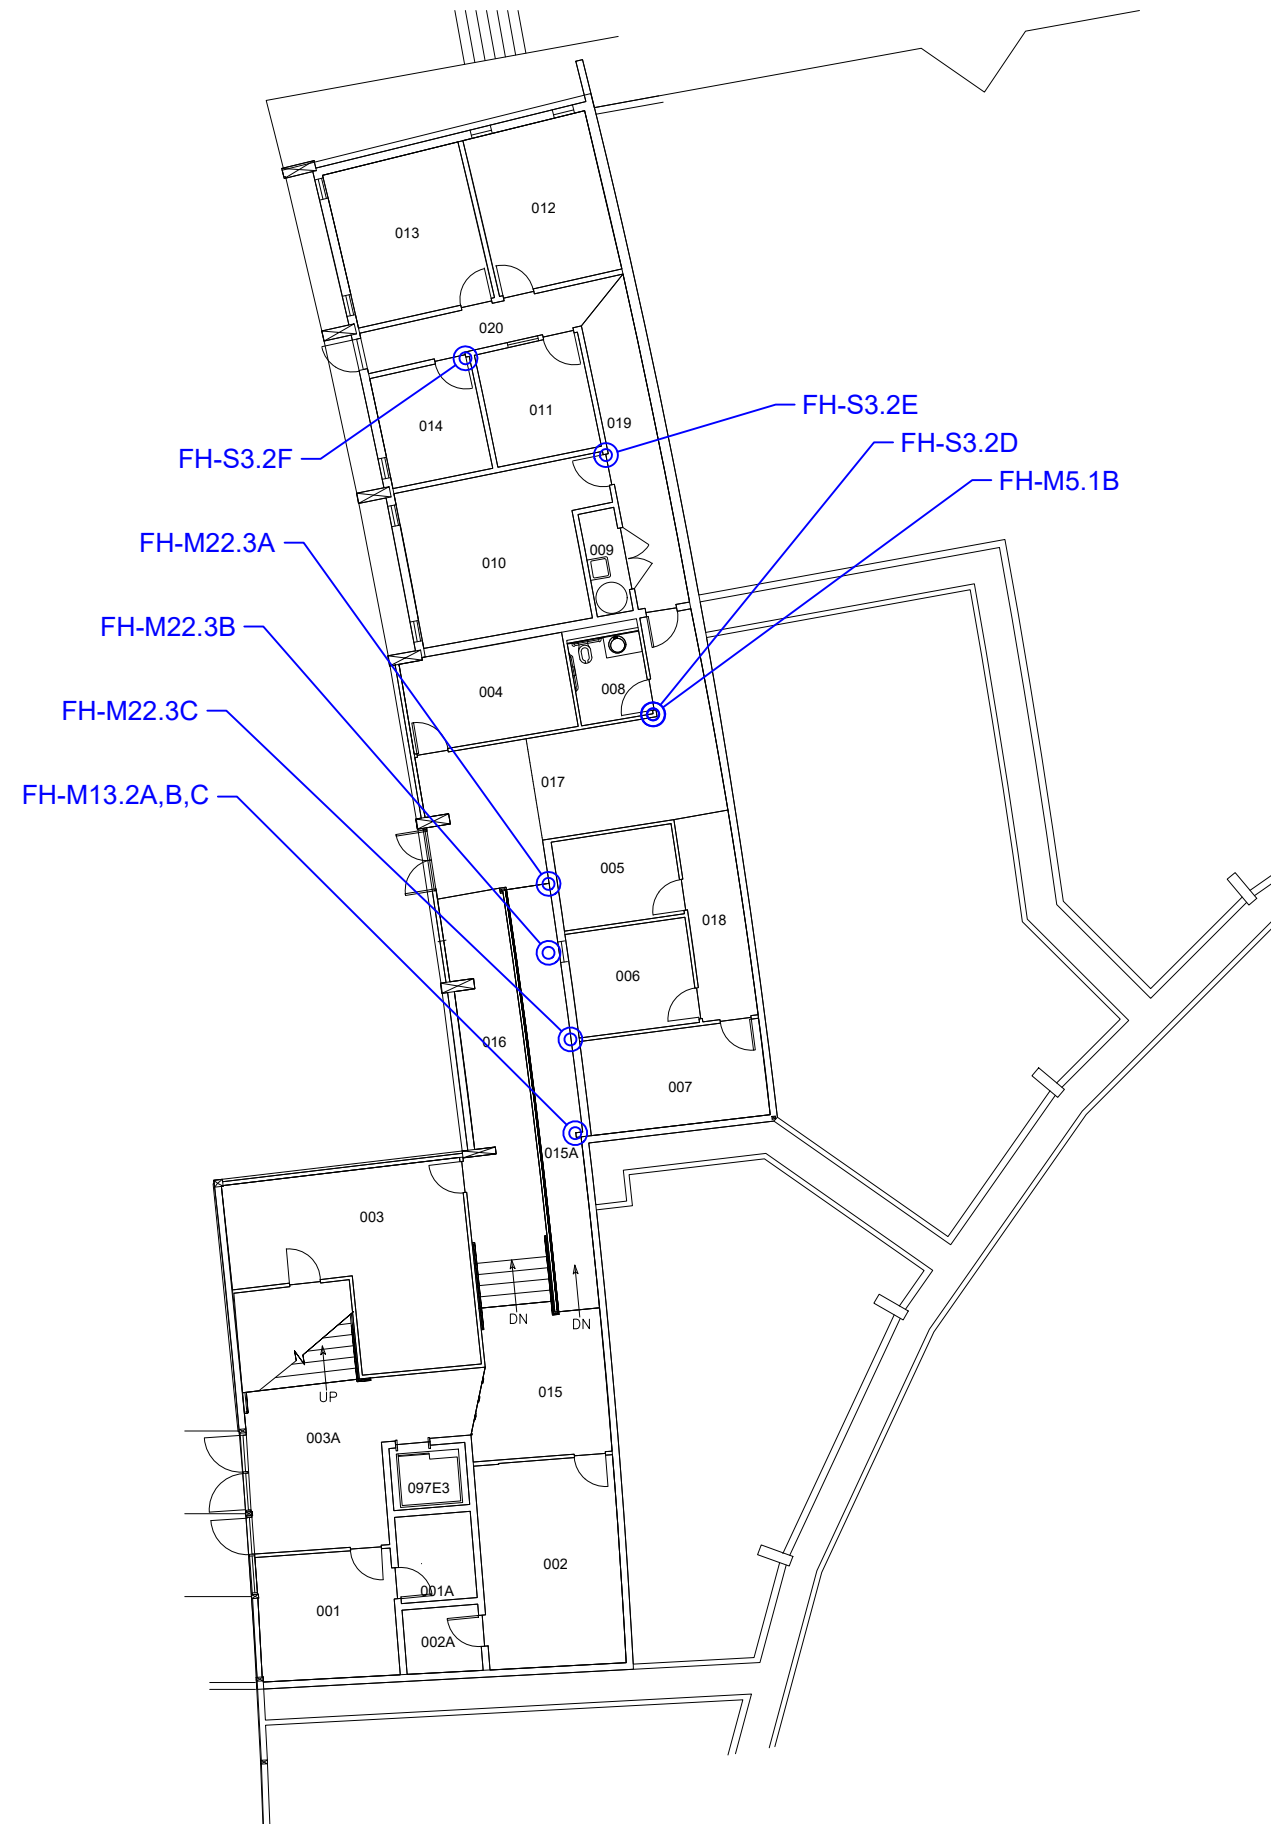
Project No.:	117-00168-
Designed By:	
Drawn By:	GAB
Checked By:	PB
<b>F-01</b>

PRE-RENOVATION ASBESTOS INSPECTION  
SAMPLE LOCATIONS  
BASEMENT FLOOR  
BRICK BREEDEN FIELDHOUSE  
MONTANA STATE UNIVERSITY  
BOZEMAN, MONTANA

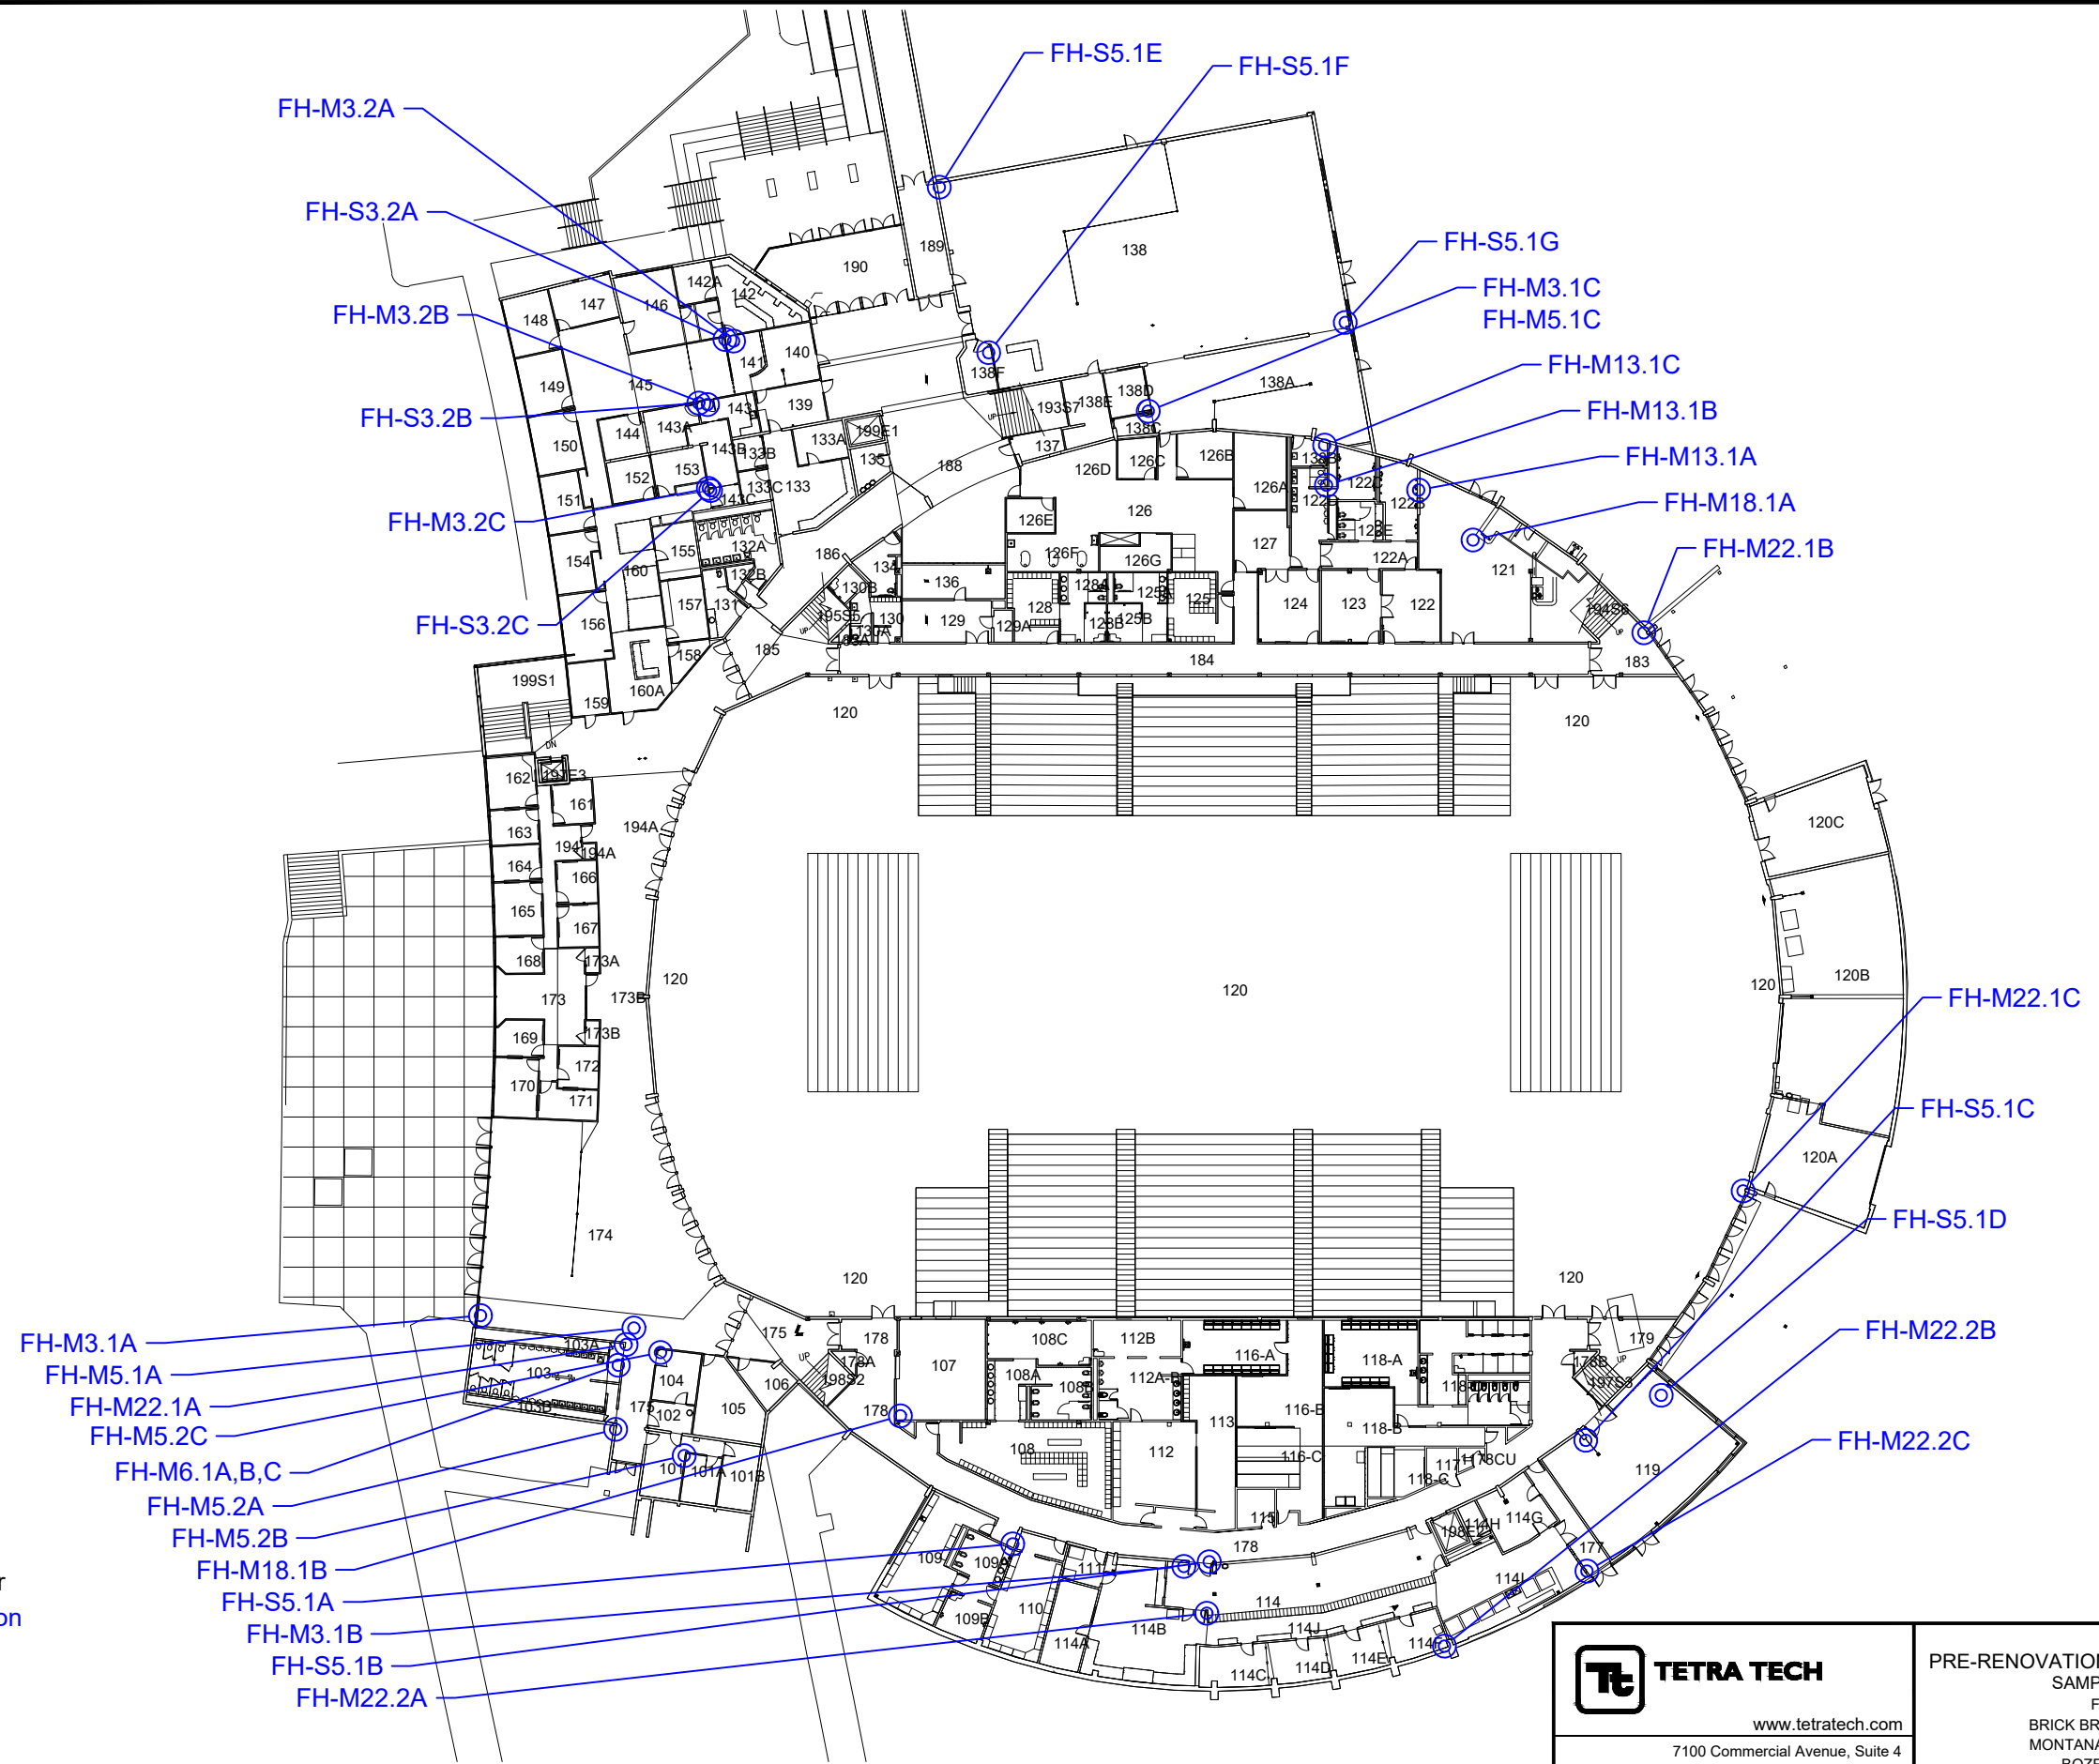
Project No.:	117-00168-
Designed By:	
Drawn By:	GAB
Checked By:	PB
<b>F-02</b>

FH-M3.1A  
 FH-M5.1A  
 FH-M22.1A  
 FH-M5.2C  
 FH-M6.1A,B,C  
 FH-M5.2A  
 FH-M5.2B  
 FH-M18.1B  
 FH-S5.1A  
 FH-M3.1B  
 FH-S5.1B  
 FH-M22.2A

PRE-RENOVATION ASBESTOS INSPECTION  
 SAMPLE LOCATIONS  
 FIRST FLOOR  
 BRICK BREEDEN FIELDHOUSE  
 MONTANA STATE UNIVERSITY  
 BOZEMAN, MONTANA

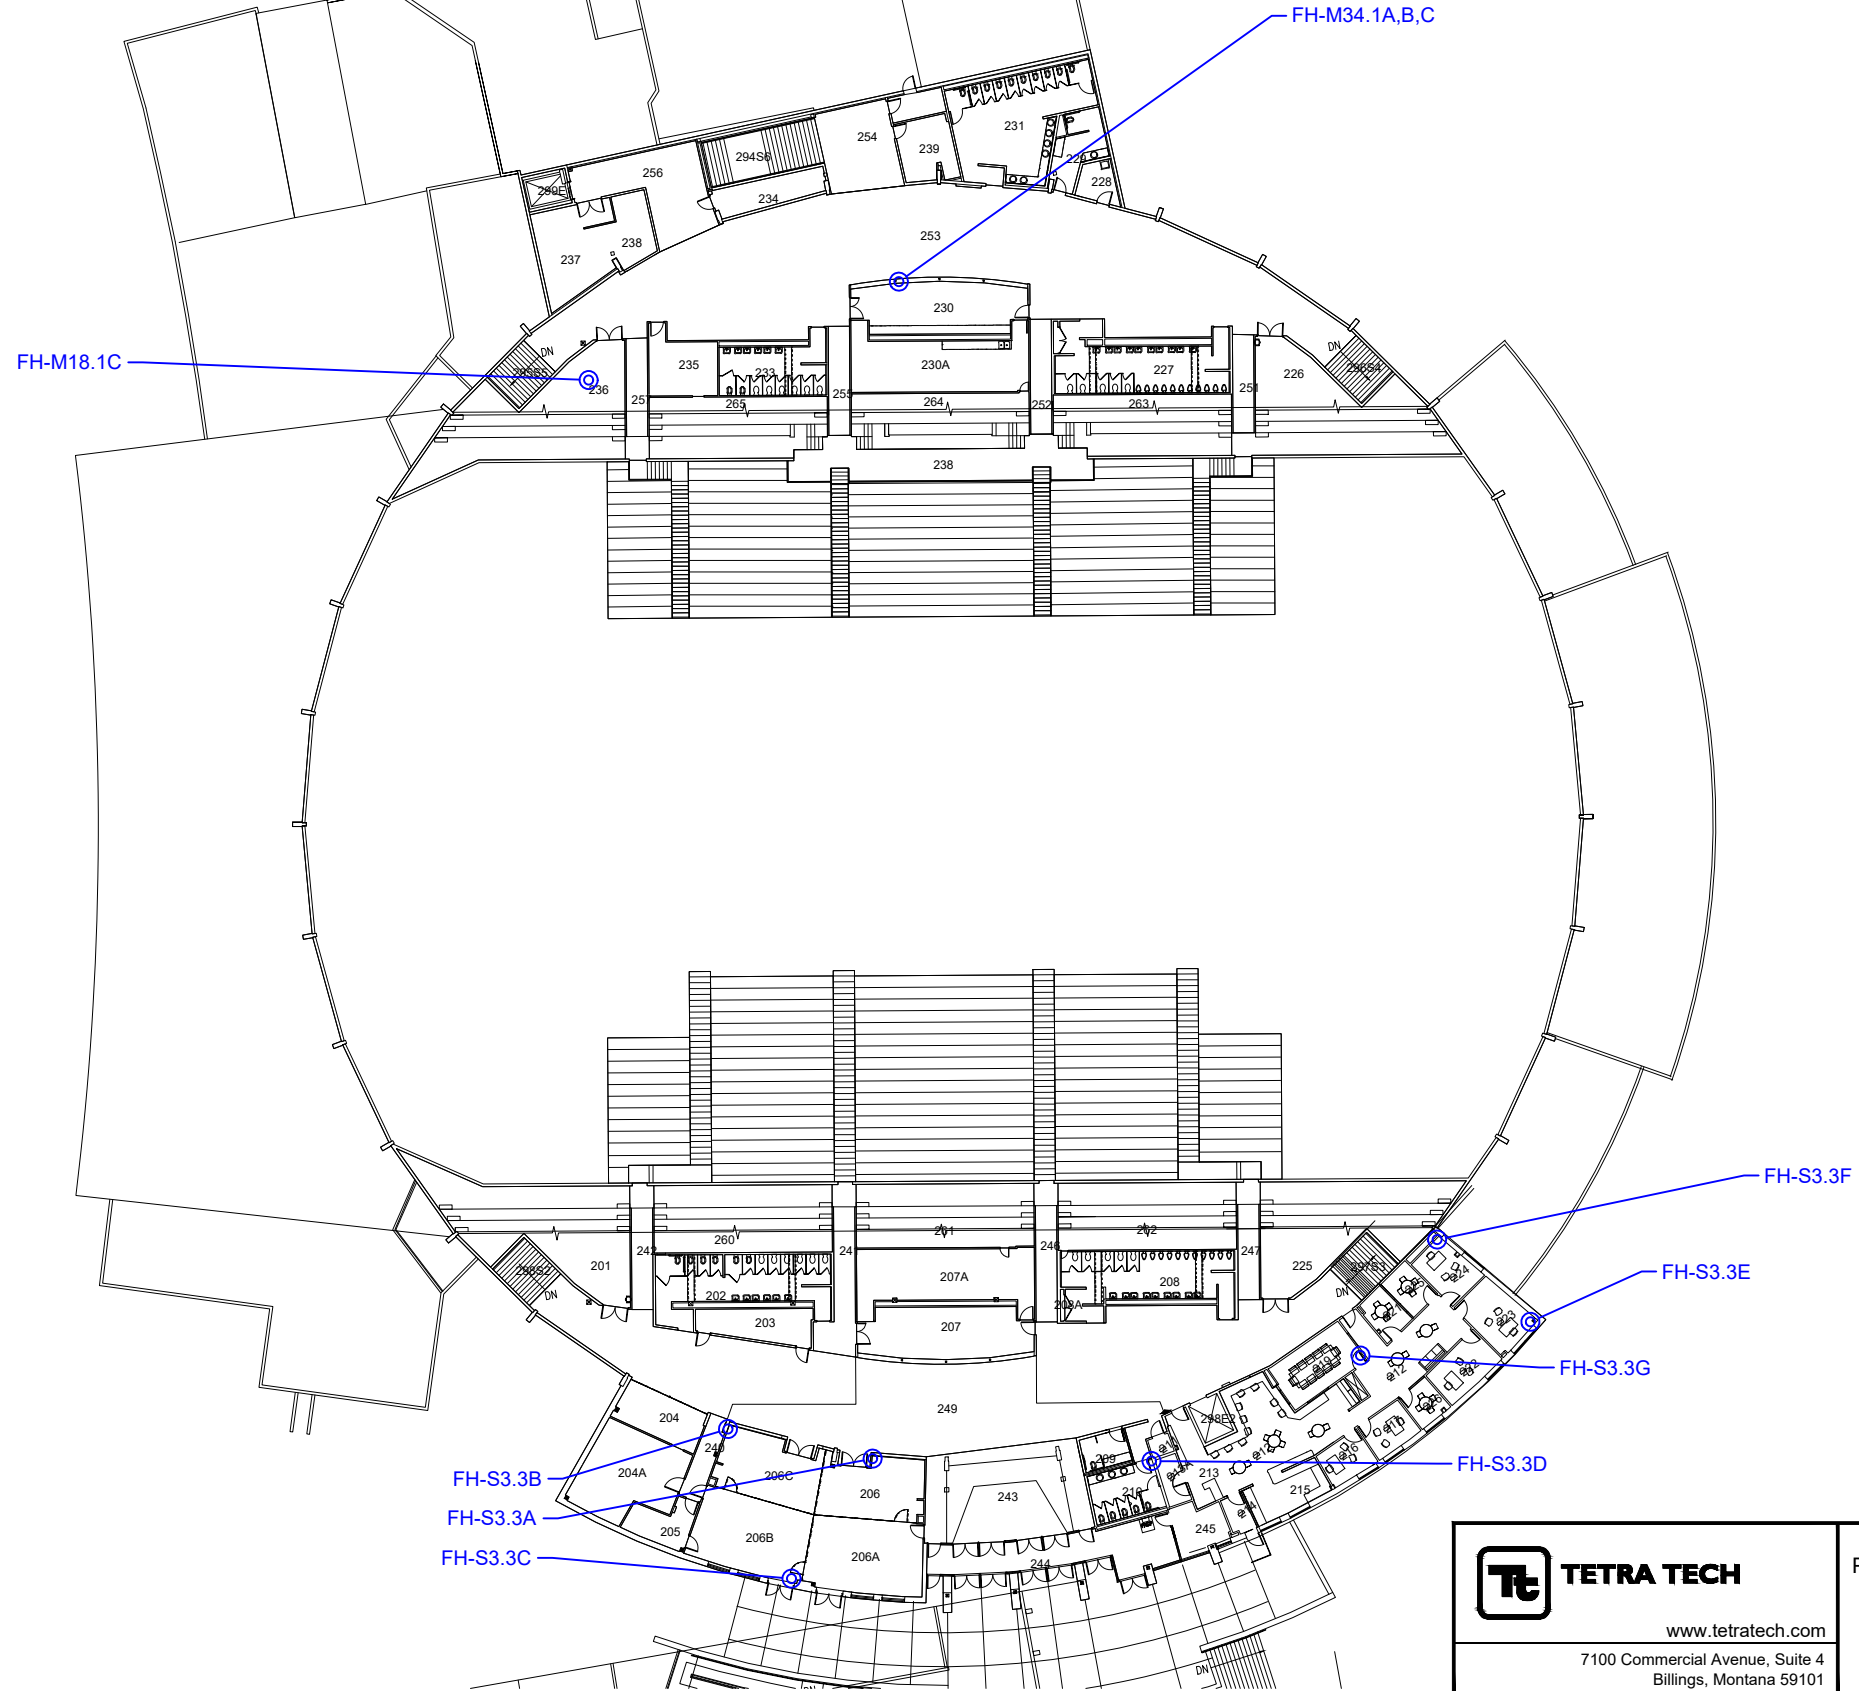
Project No.:	117-00168-
Designed By:	
Drawn By:	GAB
Checked By:	PB
<b>F-03</b>

PRE-RENOVATION ASBESTOS INSPECTION  
 SAMPLE LOCATIONS  
 SECOND FLOOR  
 BRICK BREEDER FIELDHOUSE  
 MONTANA STATE UNIVERSITY  
 BOZEMAN, MONTANA

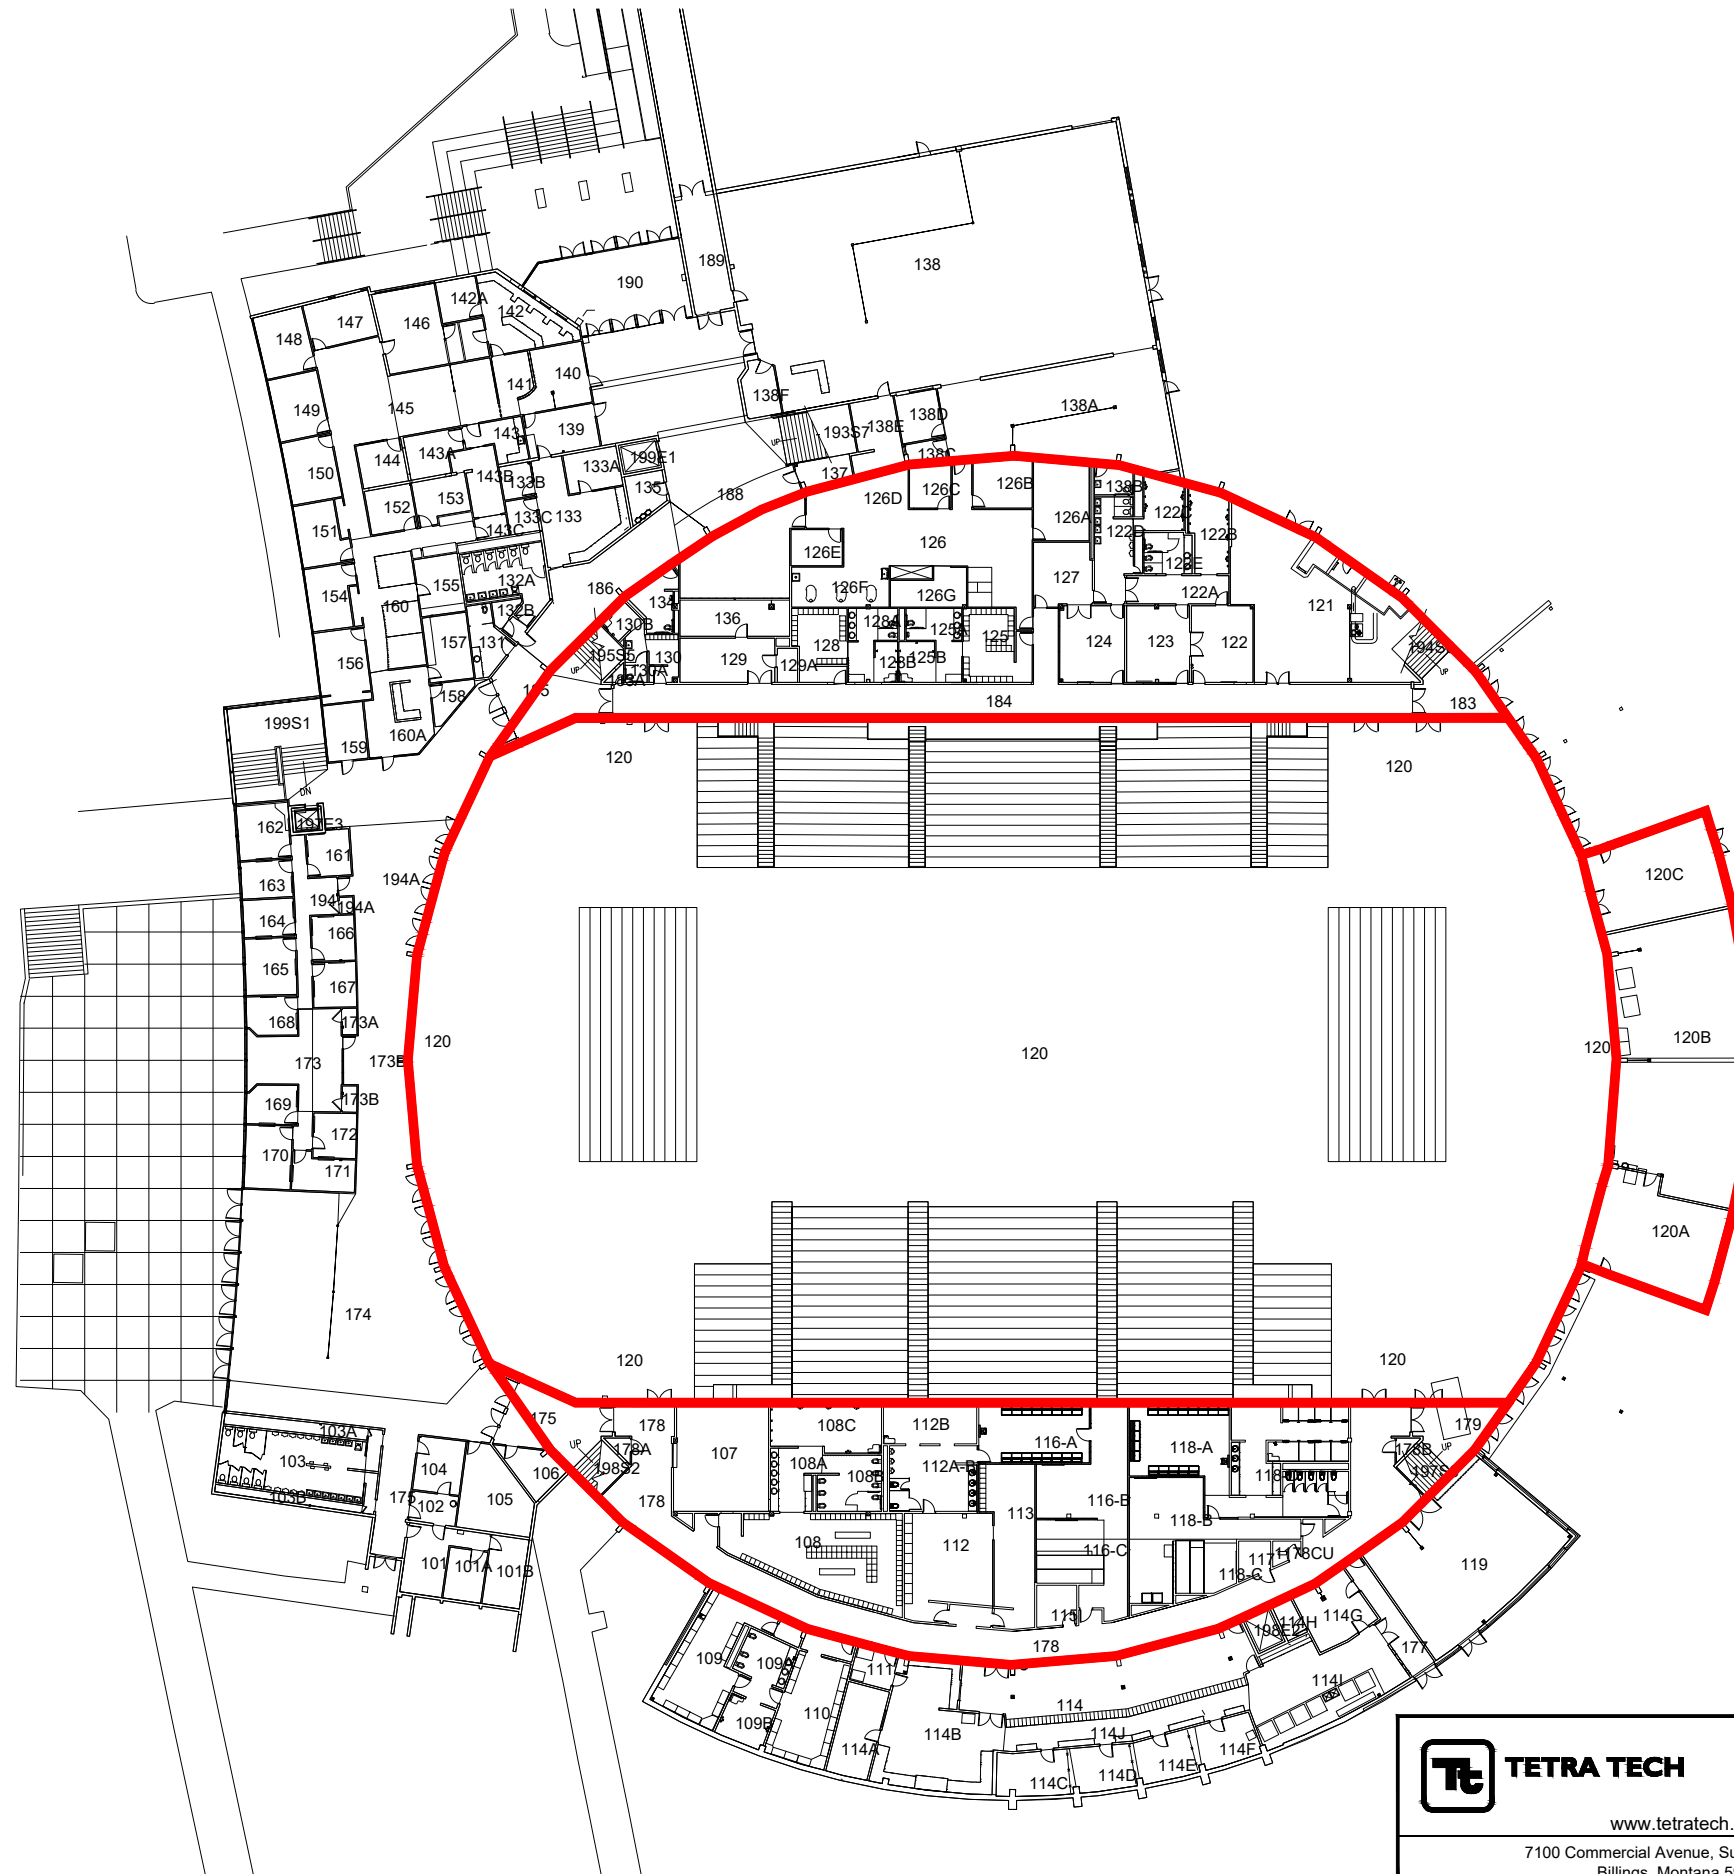
**F-04**

HA Number	Material Description and Location	Percent Asbestos	Material Type	NESHAP Category
FH-T12.1	Vermiculite insulation located in Rooms 107, 108C, 112B, 116A, 116B, 118A, 120, 120A, 120B, 120C, 121, 122B, 122C, 126, 126A, 126B, 126C, 126D, 130B, 134, 174, 175, 178, 179, 183, 184, 194, 194S, 225, 238, 249, 253, and 260-265 <sub>1</sub>	Assumed	TSI	RACM

**PRE-RENOVATION ASBESTOS INSPECTION**  
**ASBESTOS CONTAINING MATERIAL LOCATIONS**  
 FIRST FLOOR  
 BRICK BREEDEN FIELDHOUSE  
 MONTANA STATE UNIVERSITY  
 BOZEMAN, MONTANA

According to state and federal regulations, the ACM identified in **Table 1** must be removed before disturbance. The ACM must be removed by a licensed asbestos abatement contractor using appropriate asbestos abatement methods and procedures following applicable state and federal regulations. Following the completion of asbestos removal, a visual inspection and asbestos air clearance need to be conducted as required by ARM 17.74.357. Any contractor preparing to bid or perform work on the site should be informed of the potential presence of ACMs. Contractors should also be informed of compliance requirements under current state and federal regulations.

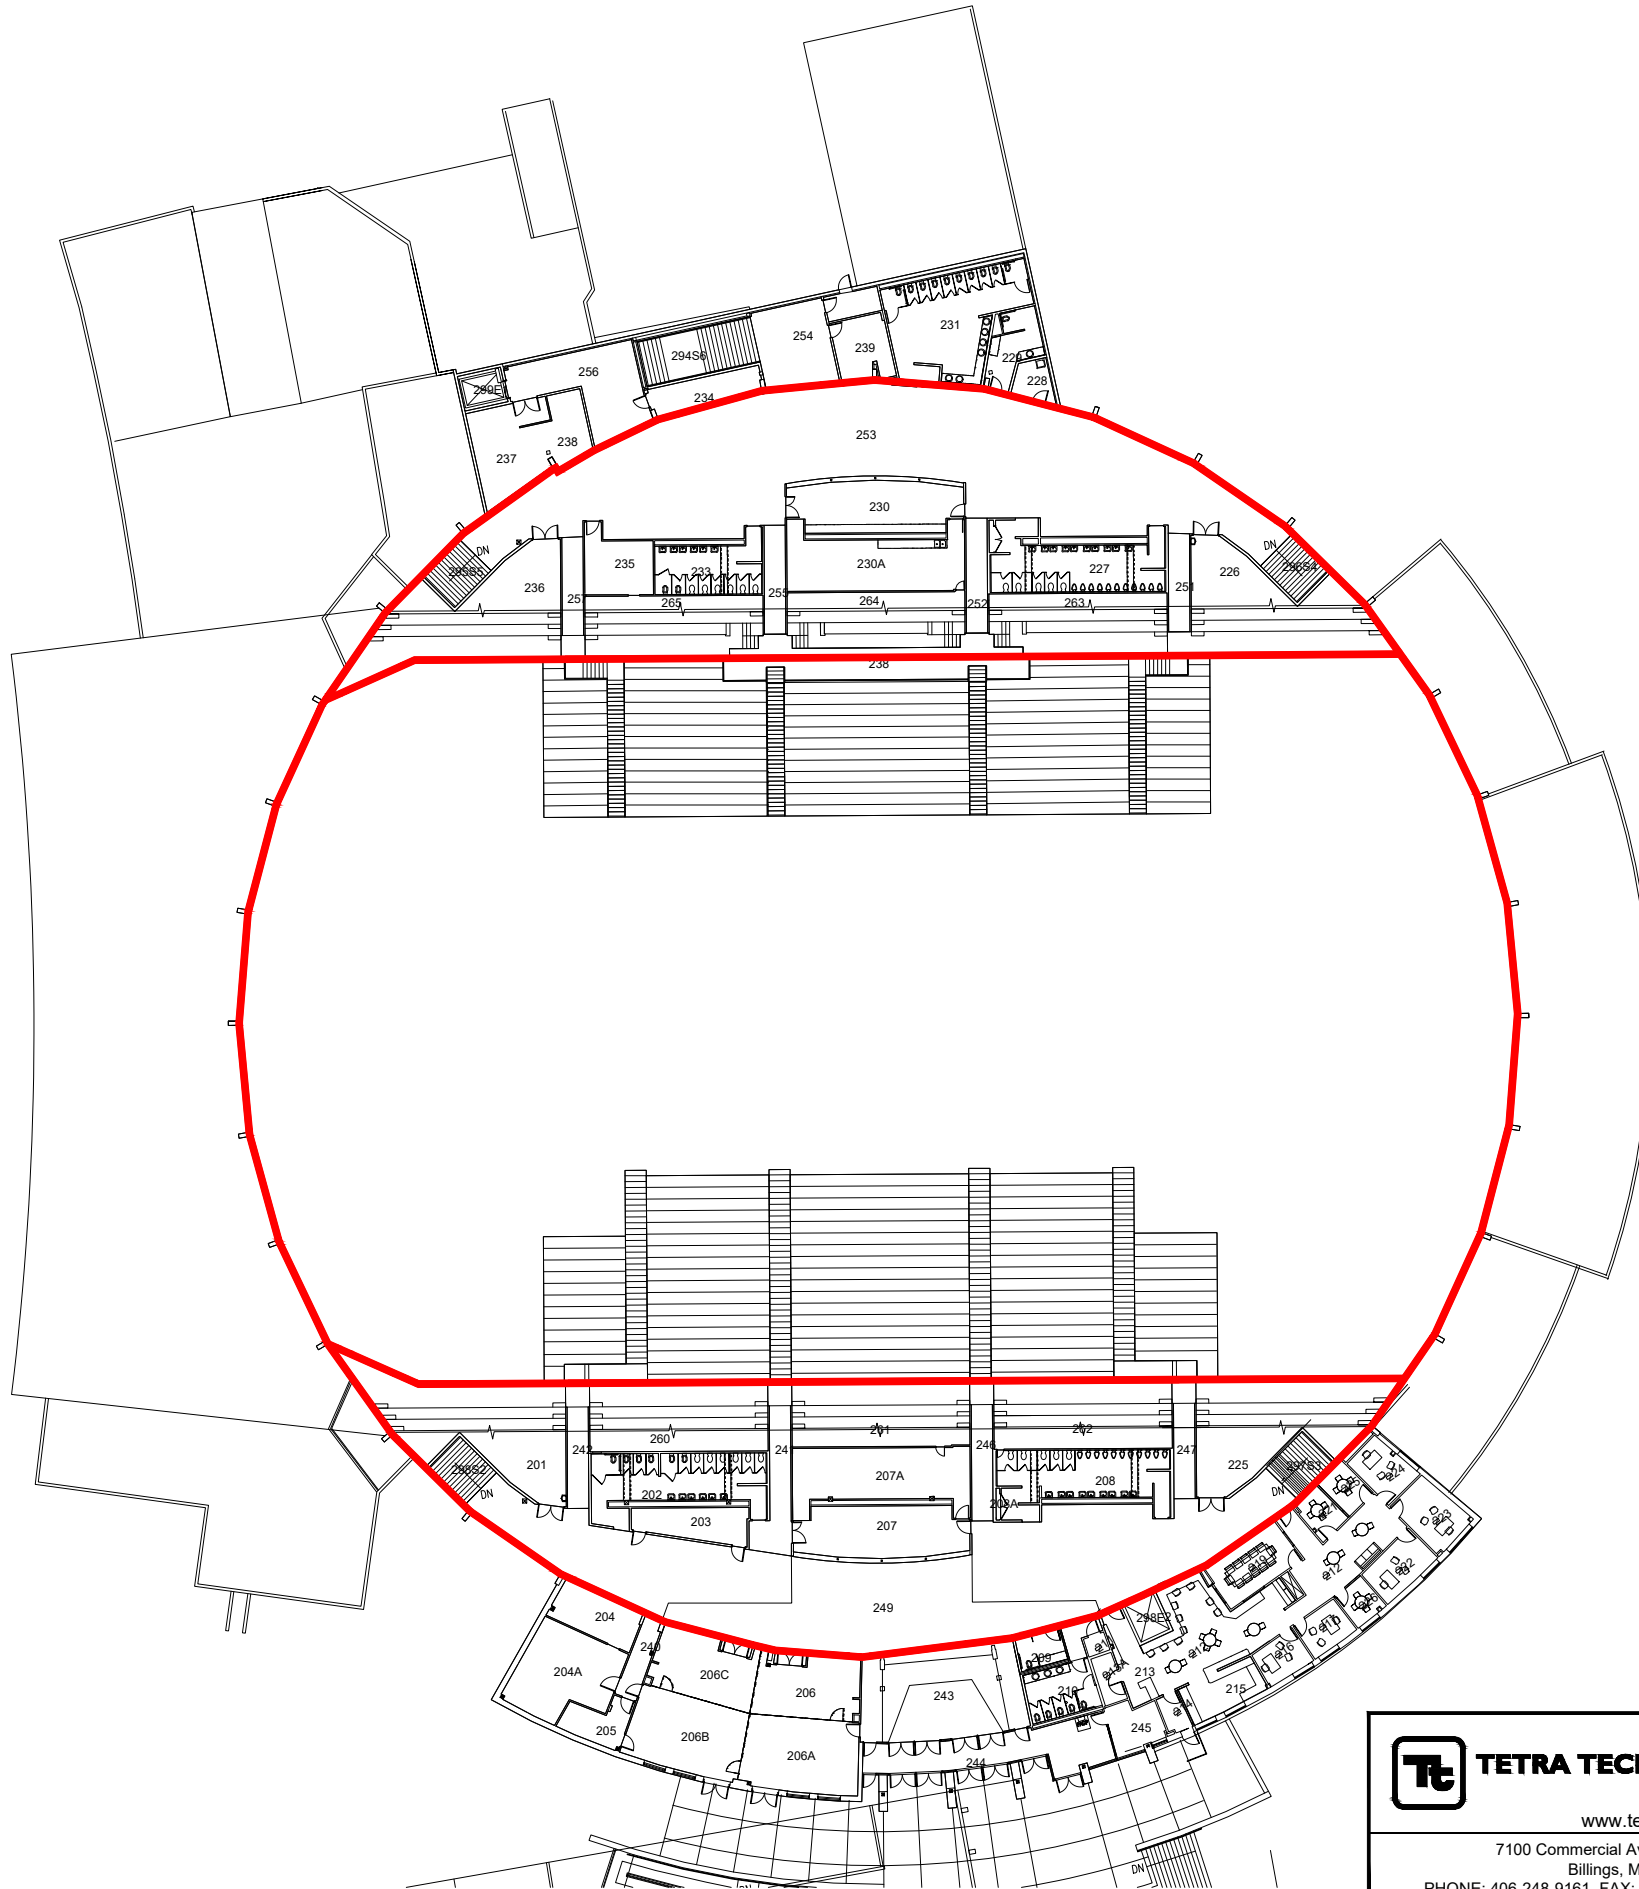
Project No.:	117-00168-
Designed By:	
Drawn By:	GAB
Checked By:	PB
<b>F-05</b>

**PRE-RENOVATION ASBESTOS INSPECTION**  
**ASBESTOS CONTAINING MATERIAL LOCATIONS**  
 SECOND AND THIRD FLOORS  
 BRICK BREEDEN FIELDHOUSE  
 MONTANA STATE UNIVERSITY  
 BOZEMAN, MONTANA
